MEMORANDUM REPORT ARBRL-MR-03279

BLAST LOADING OF CLOSURES FOR USE ON SHELTERS

George A. Coulter

June 1983

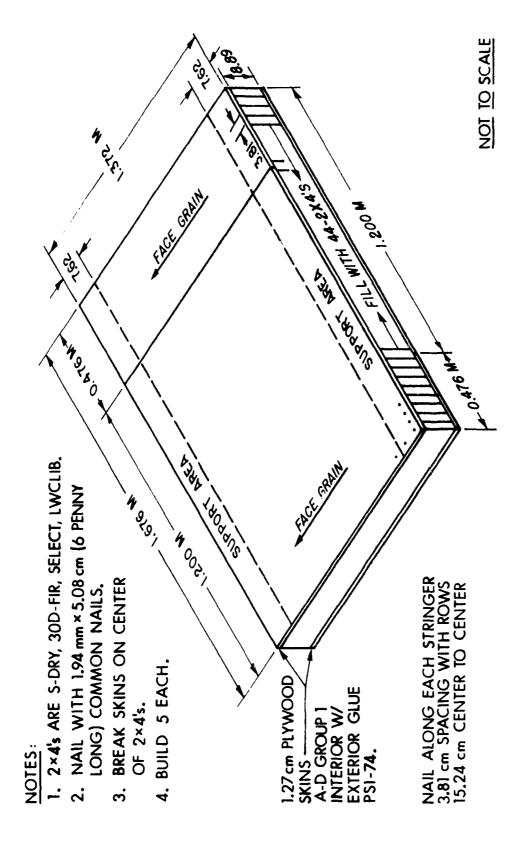
Figure 2. Wood beam/plywood close

The beam closure shown in Figure 2 was made of $2.81 \times 8.89 \text{ cm}$ ($2 \times 4's$) joists on edge, sandwiched and nailed, between sheets of 1.27 cm thick plywood. The short ends were supported with a length of 7.62 cm during the tests of this closure. As noted on the sketch, the face grain of the plywood sheets ran in the direction of the $2 \times 4's$ to give the greatest strength.

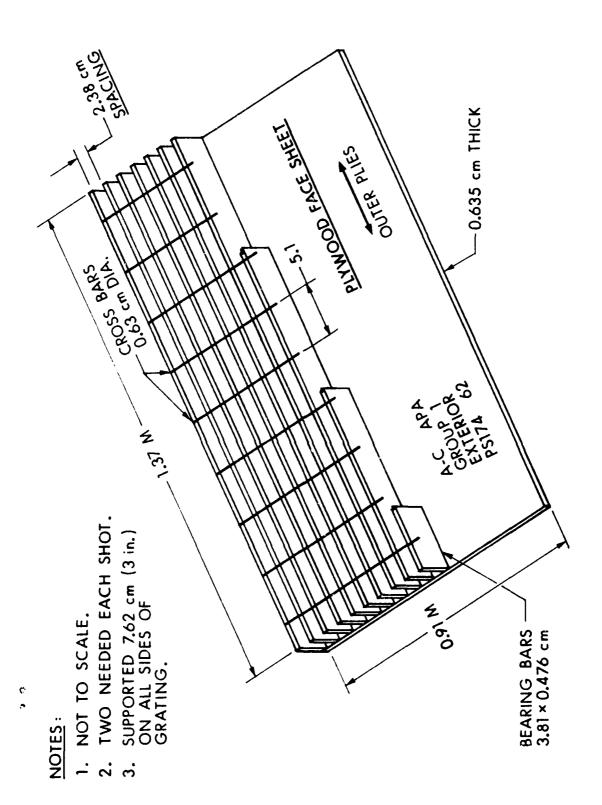
Figure 3. Steel grating/plywood closure.

Figure 3 shows a sketch of ordinary steel grating, covered on one side with plywood (0.635 or 1.27 cm) to contain the blast pressure. The grating normally is sold in a standard width of 0.91 m, so two widths were attached to cover the end flange opening of 1.219 x 1.676 m. Grating was supported 7.12 cm on all sides.

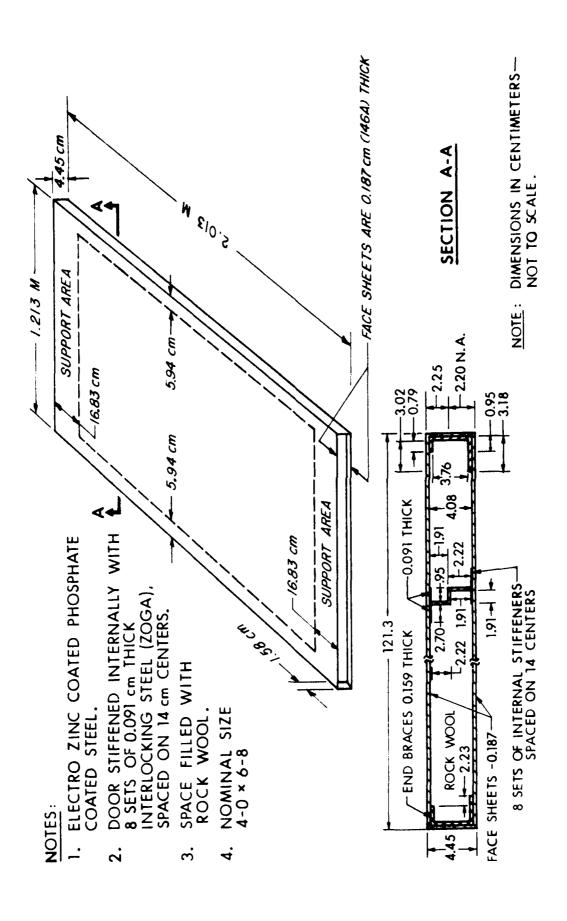
Figure 4. Commercial steel door.

The third closure tested is shown in the sketch, Figure 4. It is the strongest of a set of commercial doors tested before (Reference 3) for FEMA. The doors were full-flush steel, no cutouts, and had internal bracing with a filler of rock wool for insulation. See Figure 4 for supported areas on each edge.

The steel doors tested were a flush-type with steel face plates. Some internal stiffeners were used in the construction of the doors. See Figure 4 in Test Procedure for view of cross section.

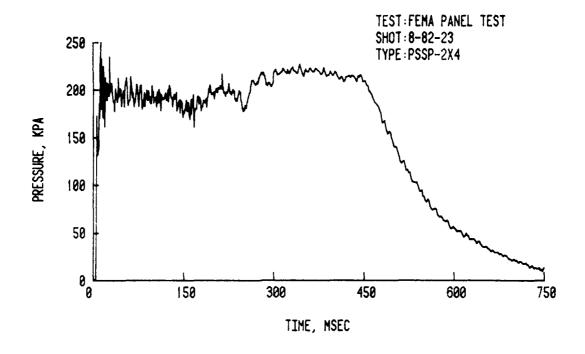
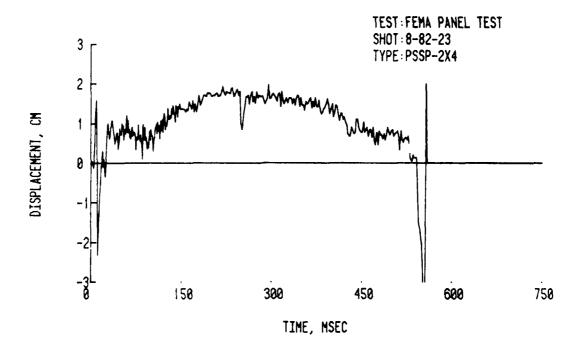
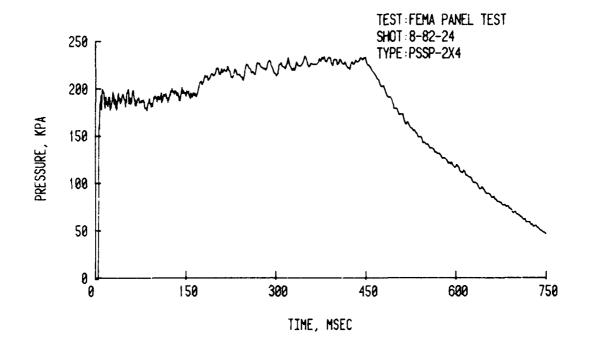
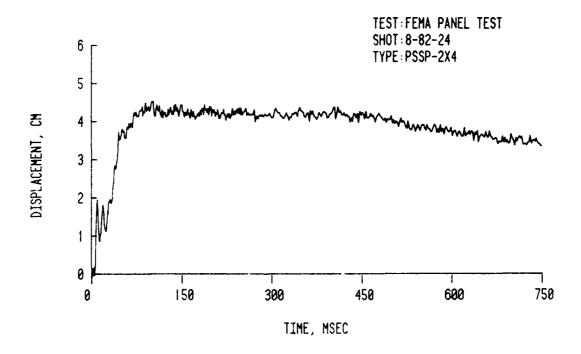
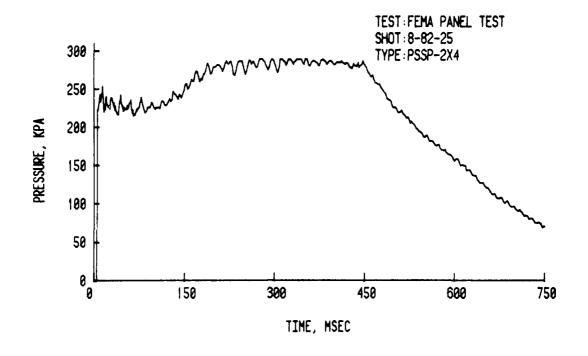
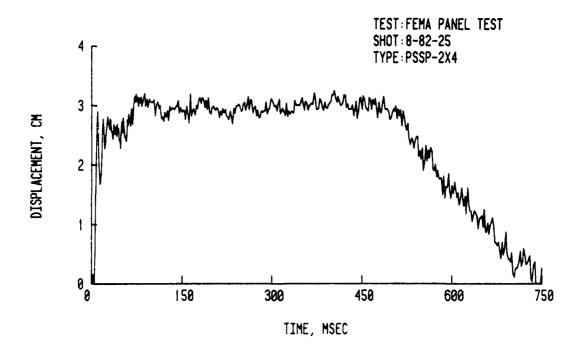
Figure 6. Pressure and displacement records for wood closures.

The wood beam/plywood closures (Shots 8-82-23 to 8-82-27) were tested through a range of loading pressures from 173 kPa (25.1 psi) to 300 kPa (43.5 psi). Slight damage to the downstream plywood skin by budging occurred at the low end of loading range. At 300 kPa (43.5 psi), the closure was in place and effective although the downstream plywood skin was broken. Two frequencies of vibration were measured for the wood closure: an initial higher one of 102-121 $\rm H_Z$ and a lower secondary one of 16-20 $\rm H_Z$. Under higher loads approaching ultimate failure (breakout), these vibrations tend to damp out.

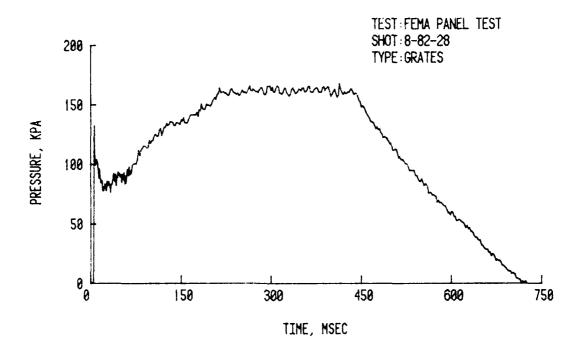
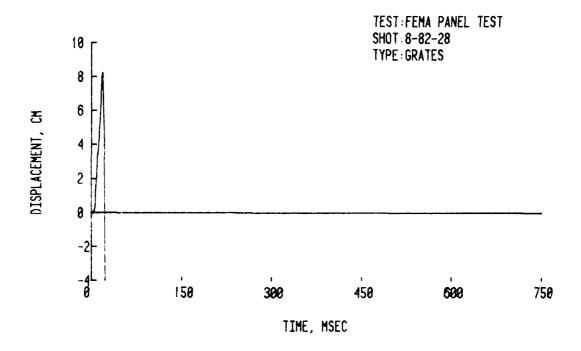
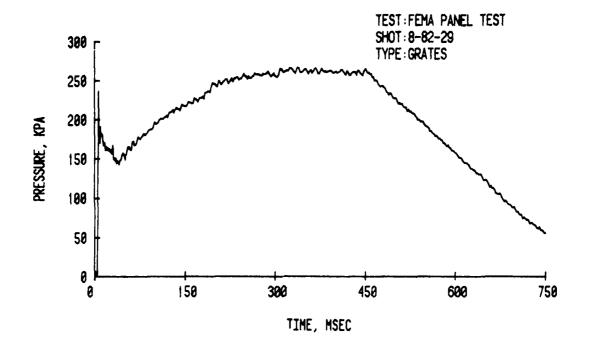
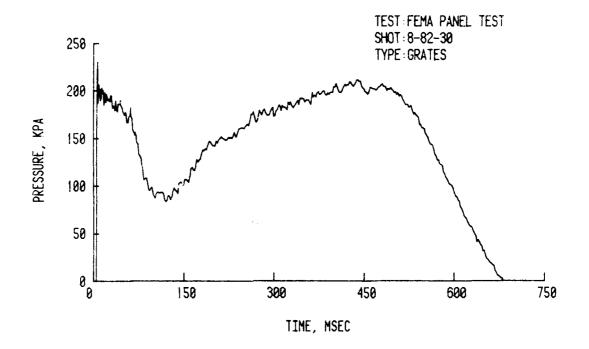
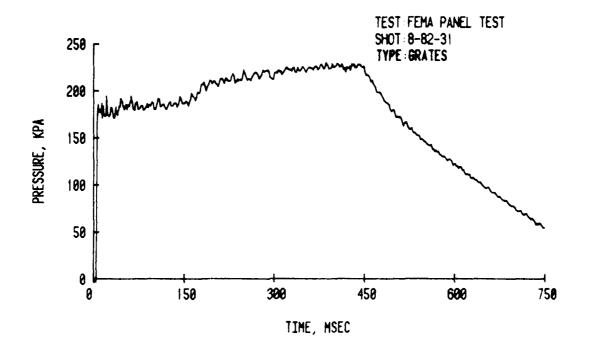
Figure 7. Pressure and displacement records for grating/plywood closures.

The loading range for the steel grating (Shots 8-82-28 to 8-82-31) varied from 131 kPa (19.0 psi) to 215 kPa (31.2 psi). The blast from Shot 8-82-28 caused the two parts of the grating (and 0.635 cm plywood sheets) to separate at the center line. No fasteners were used on this shot to hold the two gratings together. The flat rubber seal was blown through between the two gratings to allow the blast wave to blow through. Four 1.27 cm diameter U-bolts were then used on Shot 8-82-29 to fasten the two pieces of grating together. The grating remained together at a blast load of 174 kPa (25.2 psi) but some of the cross bars near the center were pulled partially loose from the bearing bars. The loading was increased to 215 kPa (31.2 psi) which blew the closure completely out of the shock tube. The pressure was decreased and the inside cover sheet was changed to 1.27 cm thick. The grain of the face plies of the plywood cover sheet was changed to a vertical (across the bearing bars) direction so the seam would not be in the middle. This grating/plywood closure operated successfully at 192 kPa (27.8 psi).
